Fairfield Inn and Suites by Marriott, Findlay, Ohio

Miracle Method Repairs a
Competitor's Failed Refinishing Work

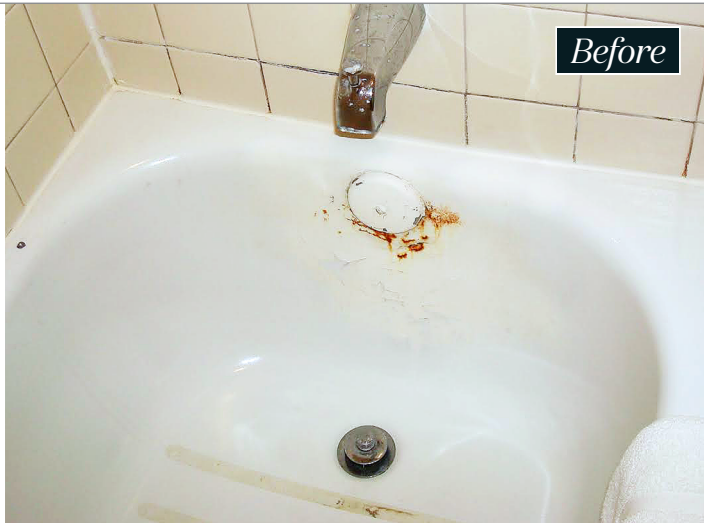
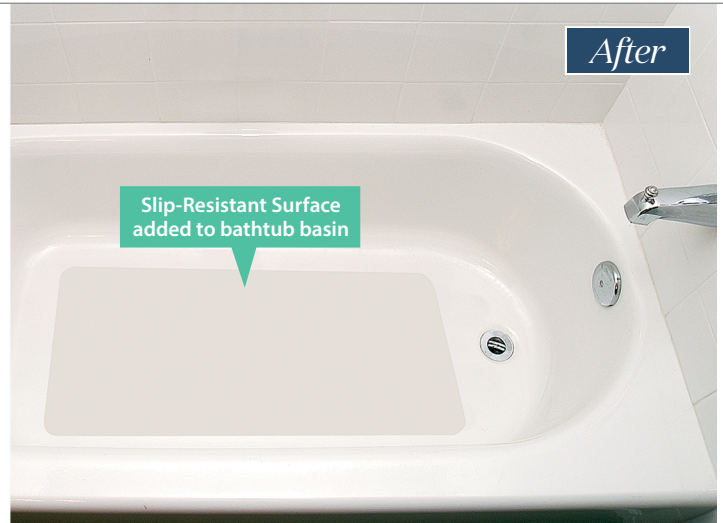
▲ A substantial amount of our commercial refinishing work is redoing a competitor's inferior refinishing.

Hotel management had identified 56 bathtubs with failing finishes. The tubs had previously been refinished by a non-Miracle Method franchise using acid etching. The coating was peeling, the slip resistant surface was coming up, and there were problems with the caulk. The failed refinishing was due to poor cleaning and the use of acid etching; while the lifting caulk was due to improper application.

Each bathtub was stripped of the defective coating, cleaned and refinished using MM-4, Miracle Method's proprietary bonding agent, to ensure the new coating would stick. Miracle Method's slip resistant surface (SRS) was then applied to the bottom of each tub. This unique SRS product bonds with the surface and will not fade, peel or discolor.
