CASE STUDY

Lima Memorial Health System, Lima, OH

30-Year Old Bathroom Tile Restored to Like New.
Now, More Modern and Easier to Maintain.

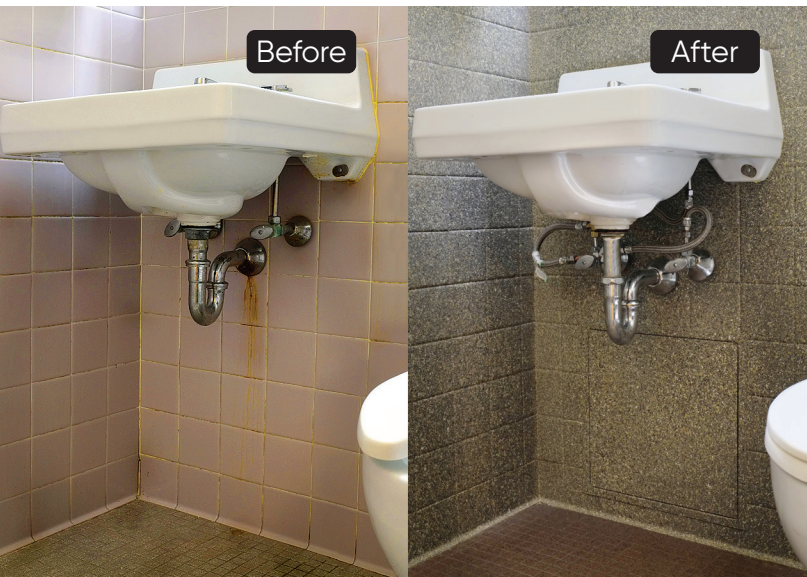
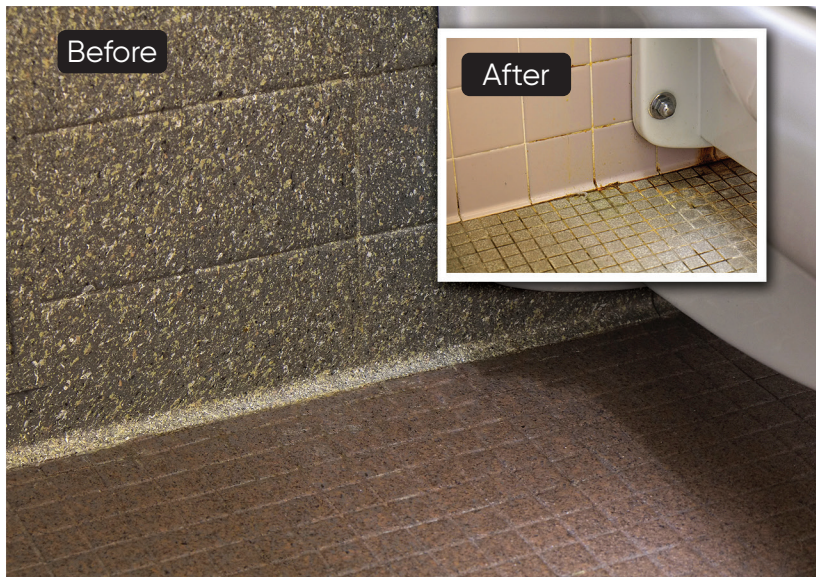
The refinished tile in the patient bathrooms looks like new and complies with the hospital's infection control program.

Pink tile in patient bathrooms in an older section of Lima Memorial were not only seriously dated, but the worn grout was becoming difficult to clean. Renovation plans were straining the budget and when Chad Martin, LMH's Director of Facilities Management, learned about Miracle Method at an American Society of Healthcare Engineering Conference, he knew he had a budget saving solution.

Miracle Method technicians made repairs to all damaged tile and grout then performed a two-step cleaning process to remove dirt and soap scum. Once clean, Miracle Method's proprietary MM-4 was applied to assure a complete bond with the new surface. This bonding agent creates a perfect foundation for a tinted epoxy primer and Miracle Method's

stone-look Natural Accents® finish. After the Natural Accents application cured, a final coat of abrasion and water-resistant clear coat was applied.

The refinished tile floors and walls were not only updated and more attractive, but much easier to maintain. Dirty grout and potential mold and mildew are no longer a problem, and the updated, stone-look color is much more pleasing to staff and patients. The 30-year old tile looks brand new and was a cost effective upgrade that did not include lengthy and costly demolition and replacement. The process had minimal impact on hospital staff and patients and will aid in the hospital's infection control program.
